SS RICHARD MONTGOMERY SURVEY REPORT 2003

RICHARD MONTGOMERY SURVEY REPORT 2003

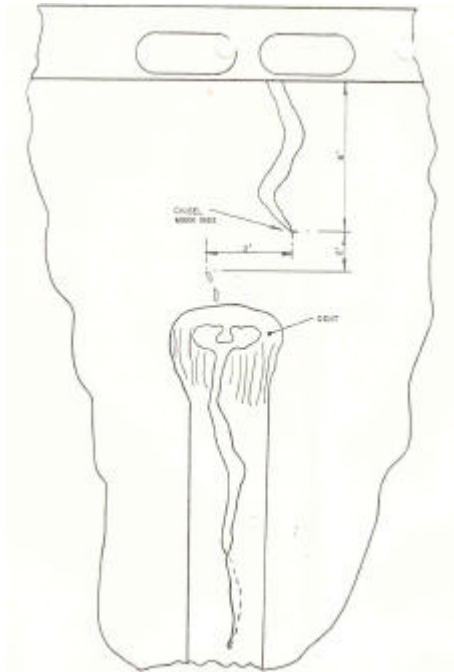
1985

28. The 1981 survey states that “The split is 5 cms wide at the hatch coaming and widens to 10 cms across the port side of the deck, breaks the bulwark (at the corner of a freeing port) and grows down the ship side widening to a 15 cms gap before disappearing into the silt level 6 metres below bulwark level. Plating is buckled with splinter fractures to a width of 1 metre on each side of the gap. On the Main Deck, the plating on the forward side of the gap in the region of the port scupper is now 7.5 cms higher than the plate opposite.”

Main crack on port side from surveys in 1985, 1991 and 2003. Approximately to scale

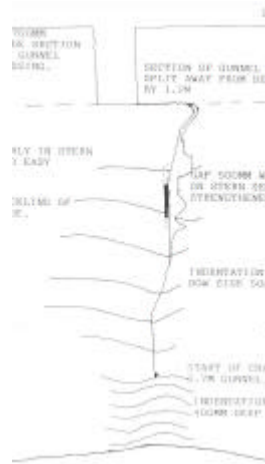
25. The 1991 survey stated that "Much of the hull plate particularly in stern section is badly corroded and easy to break away by hand. Area of crack has general buckling of plates in bank approx 3 m wide. Gap 50 cms at greatest point. Plate on stern section completely corroded. Strengthener can be felt in bow section. Difference in deck levels at split are 14 cm. Stern section lower than bow section."

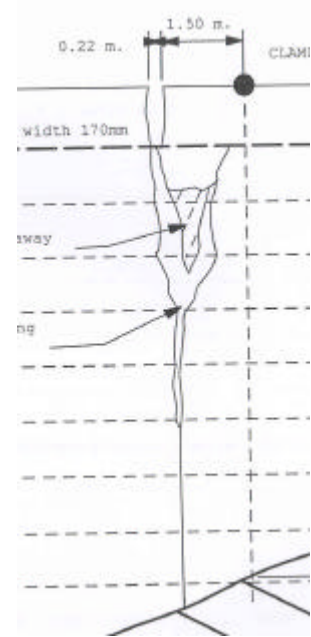
13. The 2003 survey identified that there is a gap in the gunwale of 22 cm at the top, reducing to 17 cm at deck level. The forward and stern sections are misaligned by 5 cm. The hull crack is 101.6 cm wide at 1 m below deck level and is 106.6 cm wide at 2 m below deck level. The crack was 15 cm at 3 m below deck level. At this point there was some debris protruding from the crack. At 4 m below deck level, the crack was 7 cm. At 5 m below deck level the crack was 6 cm. The crack closed completely at 16 cm below the 5 m mark. It is suggested that the central section of the Y – shaped crack may have broken away, to account for the larger crack size.

14. The deck crack associated with the hull side crack was measured 18 cm wide at 1.2 m from the gunwale. At 2 m from the gunwale it was 14 cm. The aft section of the plate was 15 cm lower than the forward section

32. There are drawings of the main crack at No 2 Hold from 1985, 1991 and 2003. These are presented alongside each other in order to give an idea of the changes over time. It will be observed that the crack has increased in width in the top three metres below deck level. However, there appears to be no significant increase in size below three metres. This suggests material falling away due to erosion around the break, rather than movement in the hull itself. From the drawings there appears to be some discrepancy over the size in the break in the gunwale. This may be due to either a misinterpretation on site (given the poor visibility) or may represent an actual change due to a shift in the wreck, though this seems unlikely as the deck crack has not materially changed in the last 10 years, and the lower part of the main crack does not appear to have altered.

36. It is recommended that a further detailed survey of the main cracks is commissioned in due course to monitor any further change to the cracks.
